**Flood Control Project Maintenance  
Levee Inspections**  
**LMA District Cover Sheet**  
**Spring 2018 Levee Inspection Results**

**Lake County Watershed Protection District**

**Spring 2018 Levee Inspection Results**

Waterway	Bank	Unit Miles
Unit No. 01 Middle Creek	Left	3.35

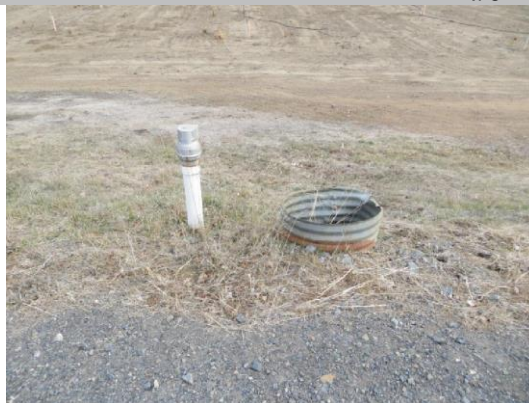
Photo 1 of 3 : UCIP\_SP\_2018\_26946\_49789.jpg

Comment Code						
Inspector Comment						
FS_ID:26946						
DS_ID:21196						
EP_NO: N/A						
Repair Type: Non-Urgent						
Crossing Status: Found						
UCIP Comments: Pump and pipe appear abandoned and should be done so properly.						
FIELD_STRUCT_DESC: *ABANDONED* 8-inch steel irrigation pipe through the levee, 3 feet below the crown. Siphon breaker in 24-inch corrugated metal riser unit on the landside (LS) slope. Pump on the waterside (WS) bank with a butterfly valve. Service pole on the WS berm. (Moitozo Brothers, Inc.). [Additional Reference(s): DWR Levee Log, 2005. USACE Sacramento O&M Manual 506.2, August 1961, (HLM 0.83)].						
FS Date: 1/9/2014

Siphon breaker in 24-inch cmp riser with vent on LS shoulder.

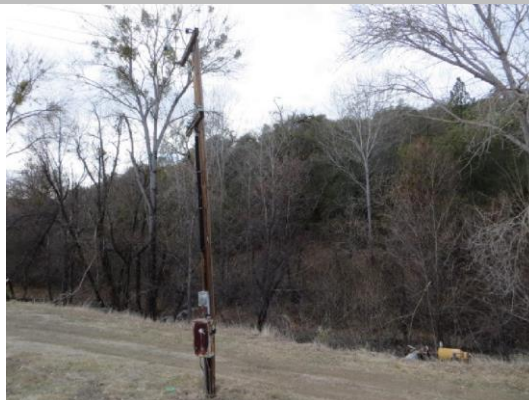
Photo 2 of 3 : UCIP\_SP\_2018\_26946\_49788.jpg

Pump, pole, and meter on WS berm.

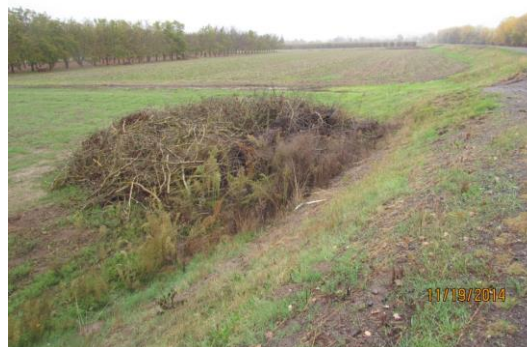
Photo 1 of 1 : SP\_2018\_NA0009\_3\_290\_20180305\_00020.jpg

LM Start	1.57	Rating **	A/W	Issue No.	290
LM End	1.57	Issue Type +	En	Location *	LS
Category	Earthen Levee			GPS Latitude/Longitude	
				Start	End
Item	Encroachments			39.169918 °	39.169918 °
				-122.915197 °	-122.915197 °
DWR ID	DWR_NA0009_01_f_2014_290				
Comment Code					
PR : Prunings					
Inspector Comment

View of the prunings along the landside toe.

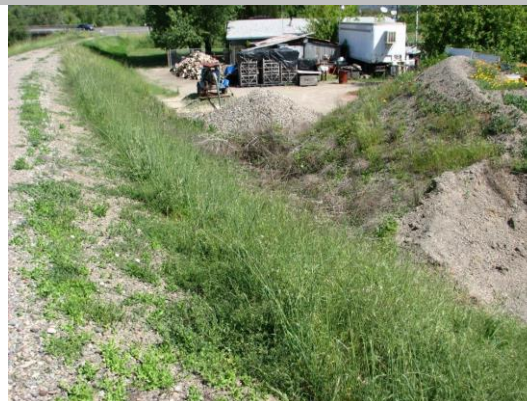
Photo 1 of 1 : SP\_2018\_NA0009\_3\_26\_20180305\_00016.jpg

LM Start	2.12	Rating **	U	Issue No.	26
LM End	2.12	Issue Type +	En	Location *	LS
Category	Earthen Levee			GPS Latitude/Longitude	
				Start	End
Item	Encroachments			39.161995 °	39.161995 °
				-122.915383 °	-122.915383 °
DWR ID	DWR_NA0009_01_s_2016_26				
Comment Code					
MA : Material					
Inspector Comment					
Remove large gravel piles from LS toe.

5/2/2016: Remove large gravel piles from L/S toe.

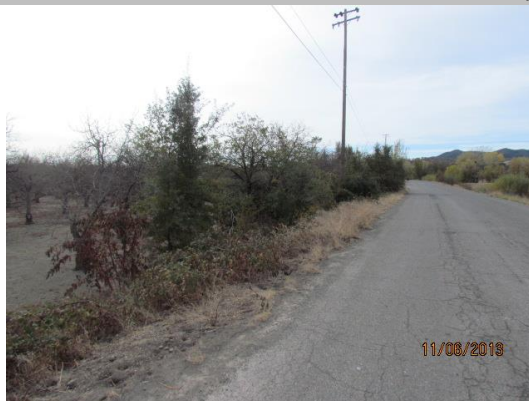
Photo 1 of 2 : SP\_2018\_NA0009\_3\_3\_20180305\_00001.jpg

LM Start	2.48	Rating **	U	Issue No.	3
LM End	2.55	Issue Type +	Ma	Location *	LS
Category	Earthen Levee			GPS Latitude/Longitude	
				Start	End
Item	Vegetation			39.161615 °	39.160804 °
				-122.911733 °	-122.912536 °
DWR ID	DWR_NA0009_01_s_2012_3				
Comment Code					
V2 : Remove the wild growth other than native grasses from the levee slopes.					
Inspector Comment

View of the vegetation along the landside slope.

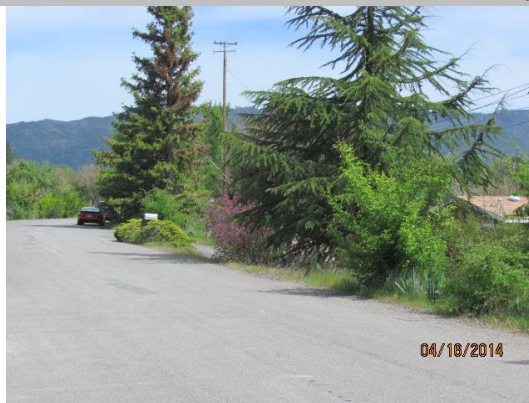
Photo 1 of 1 : SP\_2018\_NA0009\_3\_5\_20180305\_00004.jpg

LM Start	2.58	Rating **	M	Issue No.	5
LM End	2.66	Issue Type +	En	Location *	LS
Category	Earthen Levee			GPS Latitude/Longitude	
				Start	End
Item	Vegetation			39.160443 °	39.159308 °
				-122.912845 °	-122.913417 °
DWR ID	DWR_NA0009_01_s_2012_5				
Comment Code					
V6 : Landscaping					
Inspector Comment

View of the landscape along the landside slope.

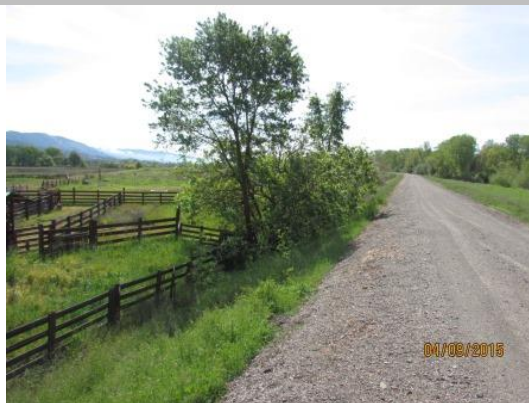
Photo 1 of 1 : SP\_2018\_NA0009\_3\_534\_20180305\_00021.jpg

LM Start	3.26	Rating **	M	Issue No.	534
LM End	3.26	Issue Type +	Ma	Location *	LS
Category	Earthen Levee			GPS Latitude/Longitude	
				Start	End
Item	Trim / Thin Trees			39.150957 °	39.150957 °
				-122.913504 °	-122.913504 °
DWR ID	DWR_NA0009_01_s_2015_534				
Comment Code					
T2 : Thin trees to allow visibility of the ground and room to flood fight.					
Inspector Comment

Remove the trees from the landside toe.

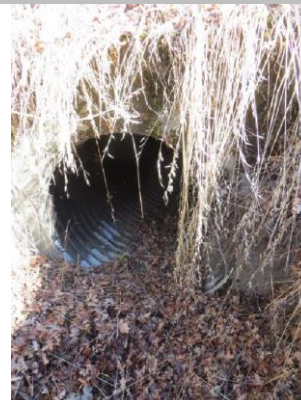
Photo 2 of 3 : UCIP\_SP\_2018\_27066\_50048.jpg

LM Start	<b>0.14</b>	Rating **	A/W	Issue No.	<b>32 (cont)</b>
LM End	<b>0.14</b>	Issue Type +	Ma	Location *

Pipe and headwall visible at LS toe in drainage swale.

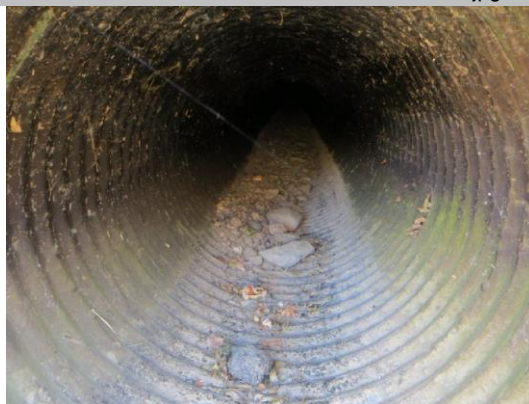
Photo 2 of 3 : UCIP\_SP\_2018\_27184\_50321.jpg

LM Start	<b>0.24</b>	Rating **	A/W	Issue No.	<b>33 (cont)</b>
LM End	<b>0.24</b>	Issue Type +	Ma	Location *

Pipe at inlet.

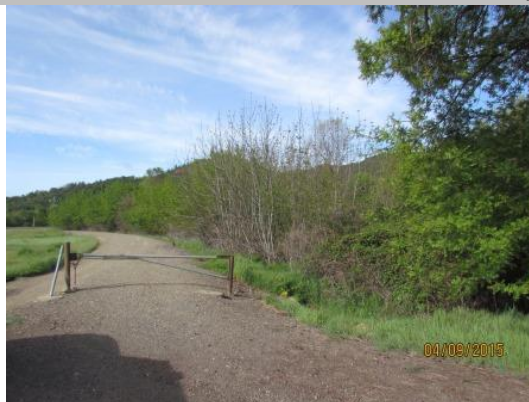
Photo 1 of 1 : SP\_2018\_NA0009\_4\_9\_20180305\_00006.jpg

LM Start	0.24	Rating **	M	Issue No.	9
LM End	0.27	Issue Type +	Ma	Location *	LS
Category	Earthen Levee			GPS Latitude/Longitude	
				Start	End
Item	Trim / Thin Trees			39.186739 °	39.186389 °
				-122.909436 °	-122.909821 °
DWR ID	DWR_NA0009_02_s_2013_9				
Comment Code					
T1 : Trim trees to at least five feet above ground level.					
Inspector Comment

View of the overgrown trees and vegetation at the landside toe.

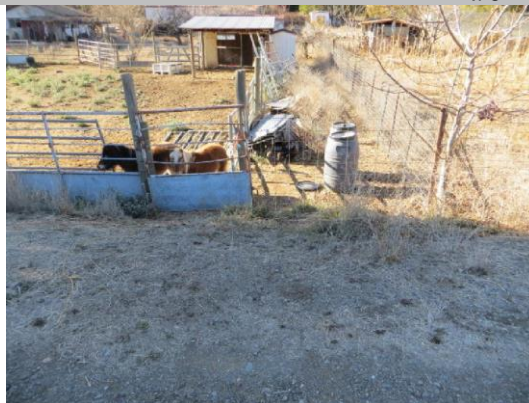
Photo 3 of 3 : UCIP\_SP\_2018\_51435\_50391.jpg

Comment Code						
Inspector Comment						
FS_ID:51435 DS_ID:21209 EP_NO: 8513 Repair Type: Urgent Crossing Status: Found UCIP Comments: 11/30/2016 Pipe not in use per LMA representative, Scott Webb. DWR Fall inspection 2016 indicated depression along pipe alignment. According to LMA representative the new property owner is Tracy Joe Hill. Need to contact owner. New owner will need to coordinate with CVFPB regarding permit name change and to address depression noted in the 2016 DWR Fall Inspection . (O. Magana - DWR UCIP)01/14/2014 Appears pipe is leaking on WS toe of Levee at mud pit. (W. Wylie - DWR UCIP) FIELD_STRUCT_DESC: 1 of 2: 1.25-inch steel groundwater pipe through the levee, 2 feet below the levee. Steel cutoff wall around pipe at center of levee. Well with 8-inch casing on waterside (WS) slope. (1.25-inch water pipe and 0.75-inch electrical conduit authorized under Permit No. 8513, 1974 - Fisher) FS Date: 11/30/2016

Valves visible just off LS toe.

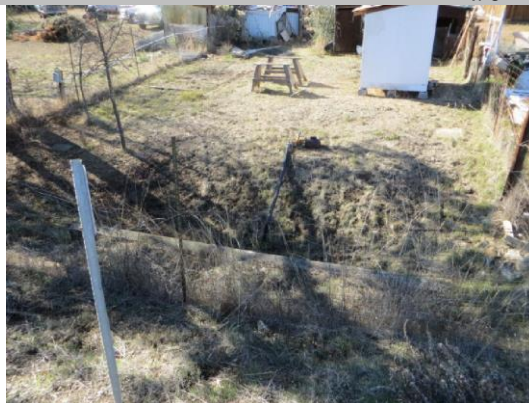
Photo 1 of 3 : UCIP\_SP\_2018\_27208\_50411.jpg

LM Start	0.55	Rating **	M	Issue No.	38
LM End	0.55	Issue Type +	Ma	Location *	
Category	Supplemental			GPS Latitude/Longitude	
				Start	End
Item	DWR UCIP LMA Responsibility			39.183130 °	39.183130 °
				-122.912198 °	-122.912198 °
DWR ID					
Comment Code					
Inspector Comment					
FS_ID:27208 DS_ID:21210 EP_NO: 11482 Repair Type: Non-Urgent Crossing Status: Found UCIP Comments: Fence on LS slope creates access issue. FIELD_STRUCT_DESC: 36-inch corrugated metal drainage pipe through the levee, 9 feet below the crown. Flap gate on the waterside (WS) end. Concrete headwalls on both ends. (36-inch pipe [HLM 0.54] retained under ABO No. 11482, 1975 - George R. and Gladys Schneider). [Additional Reference(s): DWR Levee Log, 2005. USACE Sacramento O&M Manual 506.2, August 1961, (HLM 0.54)]. FS Date: 1/14/2014

Concrete headwall on LS toe.

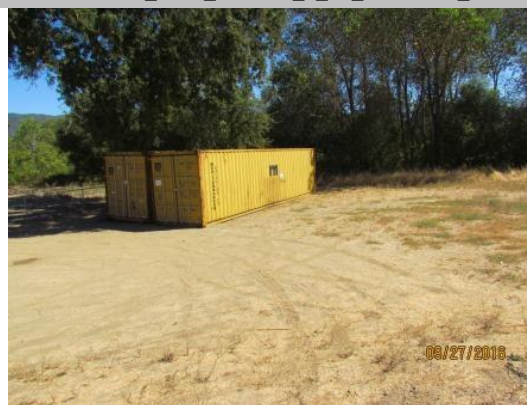
Photo 1 of 1 : SP\_2018\_NA0009\_4\_25\_20180305\_00012.jpg

LM Start	0.96	Rating **	M	Issue No.	25
LM End	0.96	Issue Type +	En	Location *	WS
Category	Earthen Levee			GPS Latitude/Longitude	
				Start	End
Item	Encroachments			39.177249 °	39.177249 °
				-122.913619 °	-122.913619 °
DWR ID	DWR_NA0009_02_f_2016_25				
Comment Code					
BU : Building					
Inspector Comment					
Two 40' shipping containers in the flood way need to be removed.

View of the shipping container in the floodway.

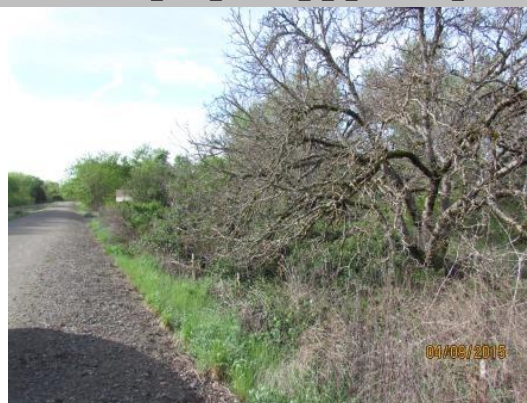
Photo 1 of 1 : SP\_2018\_NA0009\_4\_7\_20180305\_00005.jpg

LM Start	0.97	Rating **	M	Issue No.	7
LM End	0.98	Issue Type +	Ma	Location *	LS
Category	Earthen Levee			GPS Latitude/Longitude	
				Start	End
Item	Vegetation			39.177218 °	39.176992 °
				-122.913673 °	-122.913642 °
DWR ID	DWR_NA0009_02_s_2012_7				
Comment Code					
V2 : Remove the wild growth other than native grasses from the levee slopes.					
Inspector Comment

View of the vegetation at the landside toe.

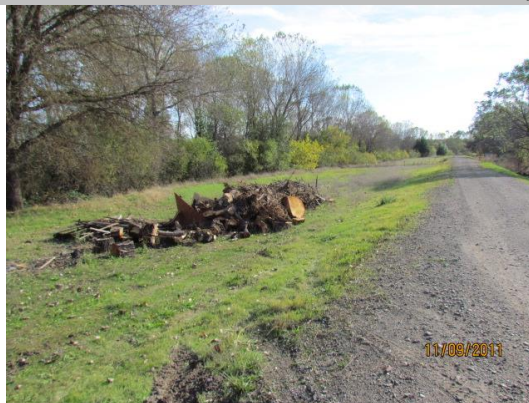
Photo 1 of 1 : SP\_2018\_NA0009\_4\_3\_20180305\_00003.jpg

LM Start	0.99	Rating **	M	Issue No.	3
LM End	0.99	Issue Type +	Ma	Location *	WS
Category	Earthen Levee			GPS Latitude/Longitude	
				Start	End
Item	Encroachments			39.176835 °	39.176835 °
				-122.913558 °	-122.913558 °
DWR ID	DWR_NA0009_02_s_2012_3				
Comment Code					
TR : Tree or limb					
Inspector Comment

View of the tree prunings on the W/S toe.

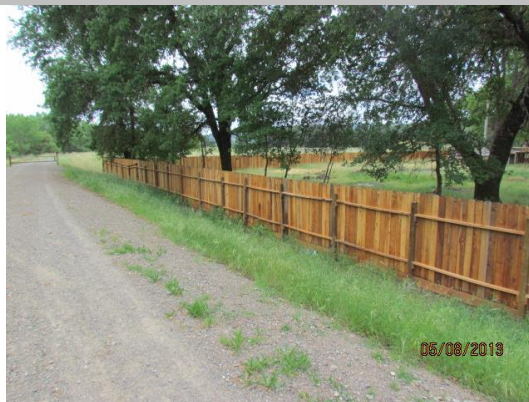
Photo 1 of 1 : SP\_2018\_NA0009\_4\_10\_20180305\_00007.jpg

LM Start	1.09	Rating **	U	Issue No.	10
LM End	1.11	Issue Type +	En	Location *	LS
Category	Earthen Levee			GPS Latitude/Longitude	
				Start	End
Item	Encroachments			39.175460 °	39.175075 °
				-122.913400 °	-122.913392 °
DWR ID	DWR_NA0009_02_s_2013_10				
Comment Code					
FE : Fence					
Inspector Comment

View of the unauthorized fence along the landside toe.

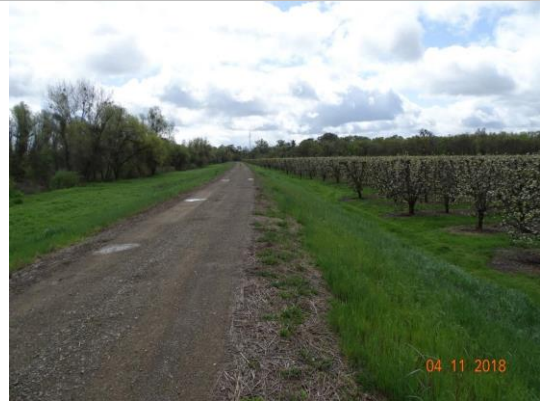
Photo 1 of 1 : SP\_2018\_NA0009\_4\_31\_20180416\_00051.jpg

LM Start	2.81	Rating **	A	Issue No.	31
LM End	2.81	Issue Type +	Ma	Location *	LS
Category	Earthen Levee			GPS Latitude/Longitude	
				Start	End
Item	Vegetation			39.151758 °	39.151758 °
				-122.915127 °	-122.915127 °
DWR ID	DWR_NA0009_02_s_2018_31				
Comment Code					
V1 : Control annual grass and weeds on the levee slopes and easements.					
Inspector Comment					
Native vegetation is well maintained on both slopes.

View of native vegetation on both slopes.

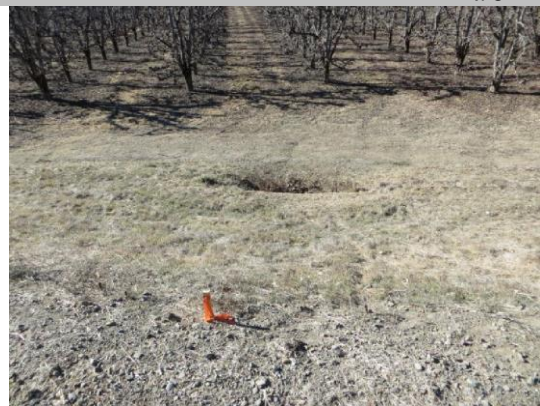
Photo 1 of 3 : UCIP\_SP\_2018\_27630\_51283.jpg

LM Start	2.84	Rating **	M	Issue No.	45
LM End	2.84	Issue Type +	Ma	Location *	
Category	Supplemental			GPS Latitude/Longitude	
				Start	End
Item	DWR UCIP LMA Responsibility			39.151257 °	39.151257 °
				-122.914908 °	-122.914908 °
DWR ID					
Comment Code					
Inspector Comment					
FS_ID:27630 DS_ID:21215 EP_NO: 11481 Repair Type: Non-Urgent Crossing Status: Found UCIP Comments: Soil partially blocking inlet and outlet. FIELD_STRUCT_DESC: 24-inch corrugated metal drainage pipe through the levee, 12 feet below the crown. Flap gate on the waterside (WS) end. Concrete headwalls on both ends. (24-inch pipe [HLM 2.93] retained under Automatic Board Order (ABO) issued as Permit No. 11481, 1975 - Dennis P. McCarthy). [Additional Reference(s): DWR Levee Log, 2005. USACE Sacramento O&M Manual 506.2, August 1961, (HLM 2.93)]. FS Date: 1/22/2014

Concrete headwall and pipe visible at LS toe.

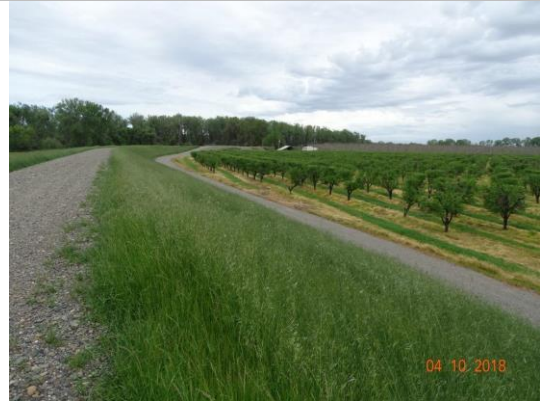
Photo 1 of 1 : SP\_2018\_NA0009\_5\_20\_20180416\_00042.jpg

LM Start	0.16	Rating **	A	Issue No.	20
LM End	0.16	Issue Type +	Ma	Location *	LS
Category	Earthen Levee			GPS Latitude/Longitude	
				Start	End
Item	Vegetation			39.149920 °	39.149920 °
				-122.915542 °	-122.915542 °
DWR ID	DWR_NA0009_03_s_2018_20				
Comment Code					
V1 : Control annual grass and weeds on the levee slopes and easements.					
Inspector Comment					
Native vegetation on both slopes will soon need management.

View of the native vegetation on both slopes.

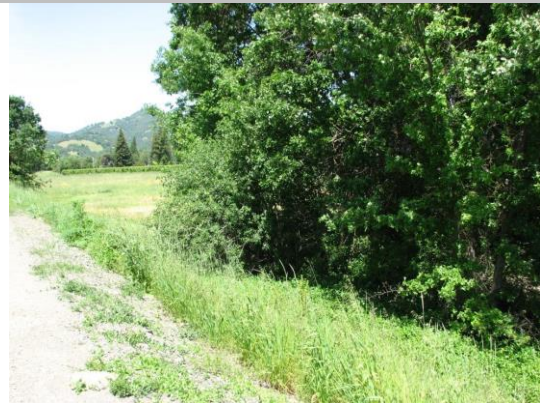
Photo 1 of 1 : SP\_2018\_NA0009\_5\_9\_20180305\_00001.jpg

LM Start	0.49	Rating **	M	Issue No.	9
LM End	0.49	Issue Type +	Ma	Location *	LS
Category	Earthen Levee			GPS Latitude/Longitude	
				Start	End
Item	Vegetation			39.154195 °	39.154195 °
				-122.918134 °	-122.918134 °
DWR ID	DWR_NA0009_03_s_2016_9				
Comment Code					
V2 : Remove the wild growth other than native grasses from the levee slopes.					
Inspector Comment

View of the overgrown trees and vegetation at the landside toe.

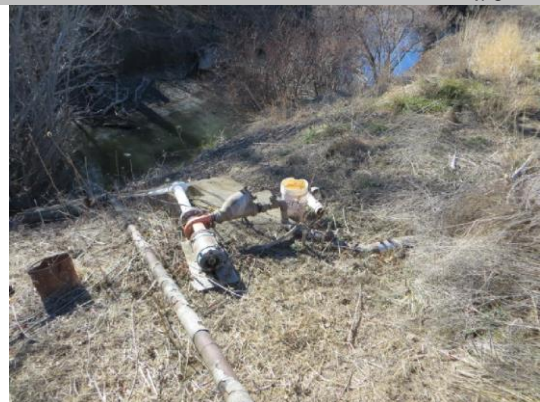
Photo 1 of 3 : UCIP\_SP\_2018\_27903\_51622.jpg

Comment Code						
Inspector Comment						
FS_ID:27903						
DS_ID:21248						
EP_NO: 11488						
Repair Type: Non-Urgent						
Crossing Status: Indicator Found						
UCIP Comments: Siphon breaker standpipe knocked over and covered with dirt. Pipe and appurtances appear to be in disrepair. Gate valves next to tank broken.						
FIELD_STRUCT_DESC: 6-inch steel irrigation pipe through the levee, 2.5 feet below the crown. Siphon breaker in 24-inch corrugated metal riser unit on the landside (LS) shoulder. Screw gate on the waterside (WS) slope next to pump and 300-gallon tank. (Pipe retained under Automatic Board Order (ABO) issued as Permit No. 11488, 1975 - Robert F. and Mary E. Wheeler). [Additional Reference(s): USACE Sacramento O&M Manual 506.2, August 1961, (HLM 1.02)].						
FS Date: 1/22/2014

Pump at concrete pad on WS berm.

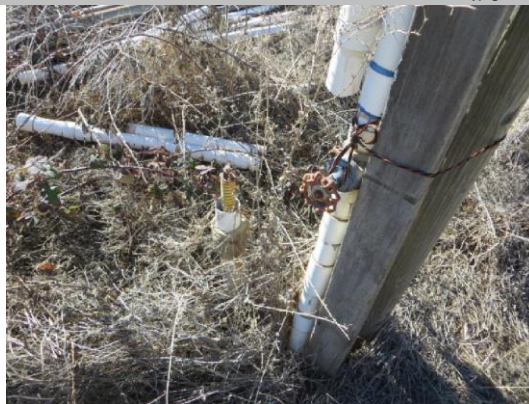
Photo 3 of 3 : UCIP\_SP\_2018\_27903\_51620.jpg

Comment Code						
Inspector Comment						
FS_ID:27903						
DS_ID:21248						
EP_NO: 11488						
Repair Type: Non-Urgent						
Crossing Status: Indicator Found						
UCIP Comments: Siphon breaker standpipe knocked over and covered with dirt. Pipe and appurtances appear to be in disrepair. Gate valves next to tank broken.						
FIELD_STRUCT_DESC: 6-inch steel irrigation pipe through the levee, 2.5 feet below the crown. Siphon breaker in 24-inch corrugated metal riser unit on the landside (LS) shoulder. Screw gate on the waterside (WS) slope next to pump and 300-gallon tank. (Pipe retained under Automatic Board Order (ABO) issued as Permit No. 11488, 1975 - Robert F. and Mary E. Wheeler). [Additional Reference(s): USACE Sacramento O&M Manual 506.2, August 1961, (HLM 1.02)].						
FS Date: 1/22/2014

filler valves on LS toe.

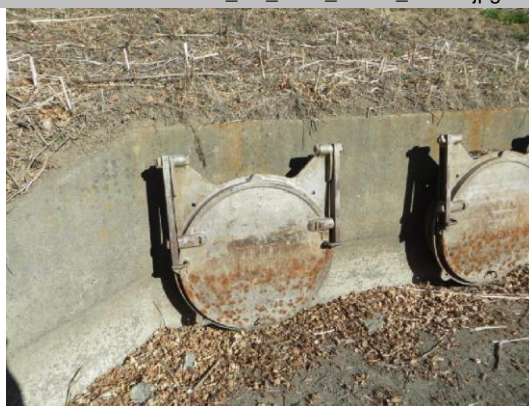
Photo 3 of 3 : UCIP\_SP\_2018\_27967\_51669.jpg

LM Start	1.24	Rating **	A/W	Issue No.	32 (cont)	
LM End	1.24	Issue Type +	Ma	Location *		
Category	Supplemental			GPS Latitude/Longitude		
				Start		End
Item	DWR UCIP LMA Responsibility			39.160386 °		39.160386 °
				-122.926239 °		-122.926239 °
DWR ID						
Comment Code						
Inspector Comment						
FS_ID:27967 DS_ID:21239 EP_NO: 11489 Repair Type: No Action Needed Crossing Status: Found UCIP Comments: FIELD_STRUCT_DESC: 4 of 4: 36-inch corrugated metal drainage pipe through the levee, 15.2 feet below the crown. Flap gate on the waterside (WS) end. Concrete headwalls on both ends. (four 36-inch pipes [HLM 1.25] retained under Automatic Board Order (ABO) issued as Permit No. 11489, 1975 - Bank of Upper Lake). [Additional Reference(s): DWR Levee Log, 2005. USACE Sacramento O&M Manual 506.2, August 1961, (HLM 1.25)]. FS Date: 1/22/2014

Flapgate on concrete headwall on WS toe.

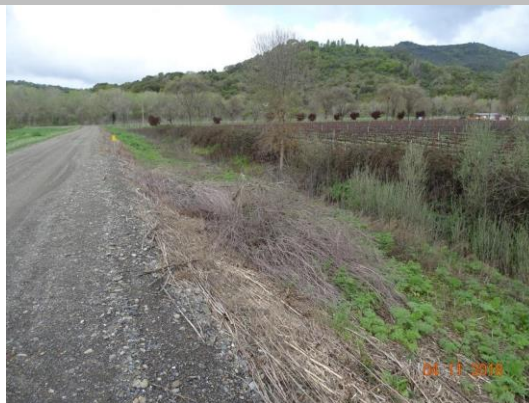
Photo 1 of 1 : SP\_2018\_NA0009\_6\_17\_20180416\_00026.jpg

LM Start	0.15	Rating **	M	Issue No.	17
LM End	0.15	Issue Type +	Ma	Location *	LS
Category	Earthen Levee			GPS Latitude/Longitude	
				Start	End
Item	Encroachments			39.176420 °	39.176420 °
				-122.909693 °	-122.909693 °
DWR ID	DWR_NA0009_04_s_2018_17				
Comment Code					
TR : Tree or limb					
Inspector Comment					
Removed the trees from the landside slope.

View of the tree along the landside slope.

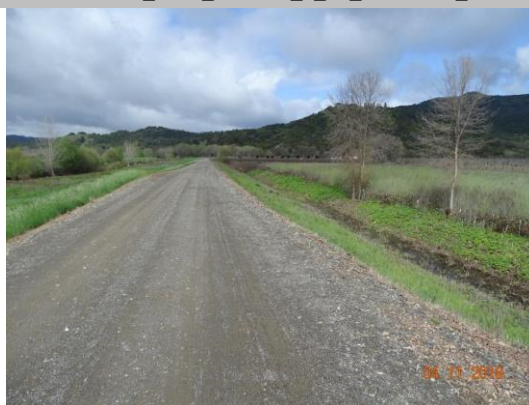
Photo 1 of 1 : SP\_2018\_NA0009\_6\_16\_20180416\_00025.jpg

LM Start	0.41	Rating **	A	Issue No.	16
LM End	0.41	Issue Type +	Ma	Location *	LS
Category	Earthen Levee			GPS Latitude/Longitude	
				Start	End
Item	Vegetation			39.176447 °	39.176447 °
				-122.904838 °	-122.904838 °
DWR ID	DWR_NA0009_04_s_2018_16				
Comment Code					
V1 : Control annual grass and weeds on the levee slopes and easements.					
Inspector Comment					
Native grasses on both slopes are adequately maintained.

View of the native grasses along both slopes.

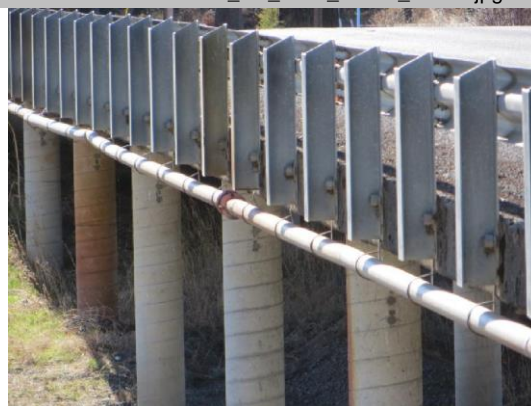
Photo 3 of 3 : UCIP\_SP\_2018\_26907\_49749.jpg

LM Start	0.53	Rating **	M	Issue No.	20 (cont)	
LM End	0.53	Issue Type +	En	Location *		
Category	Supplemental			GPS Latitude/Longitude		
				Start	End	
Item	DWR UCIP Field Study			39.176410 °	39.176410 °	
				-122.902740 °	-122.902740 °	
DWR ID						
Comment Code						
Inspector Comment						
FS_ID:26907						
DS_ID:21226						
EP_NO: 6303						
Repair Type: Non-Urgent						
Crossing Status: Found						
UCIP Comments: Pipe open on waterwardside and should be plugged.						
FIELD_STRUCT_DESC: 4-inch steel irrigation pipe through the levee,						
1.5 feet below the crown. Steel cutoff wall around the pipe at center of						
levee. Pipe connects to 4-inch exposed aluminum pipe connected to						
upstream side of bridge. (Permit No. 6303-A, 1968 - John M. Siseuich).						
[Additional Reference(s): DWR Levee Log, 2005].						
FS Date: 1/9/2014

Pipe visible on upstream side of bridge.

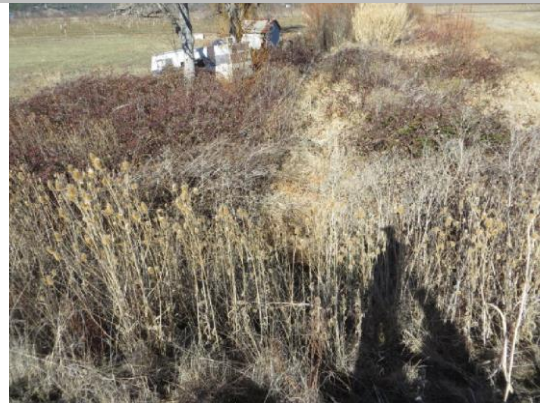
Photo 1 of 3 : UCIP\_SP\_2018\_51472\_49754.jpg

Comment Code						
Inspector Comment						
FS_ID:51472 DS_ID:21227 EP_NO: 11501 Repair Type: Urgent Crossing Status: Found UCIP Comments: 11/30/2016 Clover Creek has significant sediment build up that blocks the outlet. Crossing is still in use to drain water from LS to WS according to LMA representative, Scott Webb. (O. Magana - DWR UCIP)01/09/2014 Pipe rusted through at connection to flapgate. Good indication pipe may need replacement. Video inspection recommended. (W. Wylie - DWR UCIP) FIELD_STRUCT_DESC: 24-inch corrugated metal (CM) drainage pipe through the levee, 13.8 feet below the crown. Flap gate is located on the waterside (WS) end. Concrete headwalls located on both the WS and landside (LS) ends. (24-inch pipe [HLM 0.77] was retained under Automatic Board Order (ABO) issued as Permit No. 11501, 1975 - Sisevich). [Additional Reference(s): DWR Levee Log, 2005. USACE Sacramento O&M Manual Unit 506.2, August 1961, (HLM 0.77)]. FS Date: 11/30/2016

Drainage canal at inlet on LS toe.

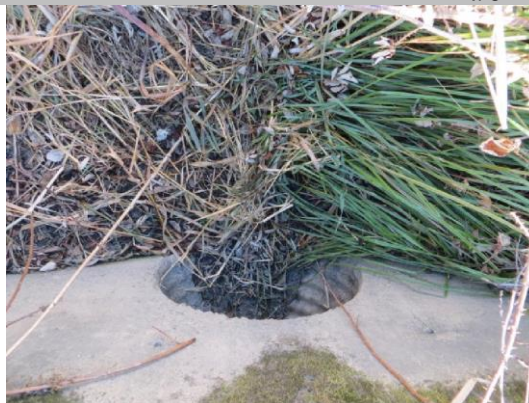
Photo 2 of 3 : UCIP\_SP\_2018\_51472\_49753.jpg

FS\_ID:51472  
DS\_ID:21227  
EP\_NO: 11501  
Repair Type: Urgent  
Crossing Status: Found  
UCIP Comments: 11/30/2016 Clover Creek has significant sediment build up that blocks the outlet. Crossing is still in use to drain water from LS to WS according to LMA representative, Scott Webb. (O. Magana - DWR UCIP)01/09/2014 Pipe rusted through at connection to flapgate. Good indication pipe may need replacement. Video inspection recommended. (W. Wylie - DWR UCIP)  
FIELD\_STRUCT\_DESC: 24-inch corrugated metal (CM) drainage pipe through the levee, 13.8 feet below the crown. Flap gate is located on the waterside (WS) end. Concrete headwalls located on both the WS and landside (LS) ends. (24-inch pipe [HLM 0.77] was retained under Automatic Board Order (ABO) issued as Permit No. 11501, 1975 - Sisevich). [Additional Reference(s): DWR Levee Log, 2005. USACE Sacramento O&M Manual Unit 506.2, August 1961, (HLM 0.77)].

Pipe and concrete headwall visible in drainage channel on LS toe.

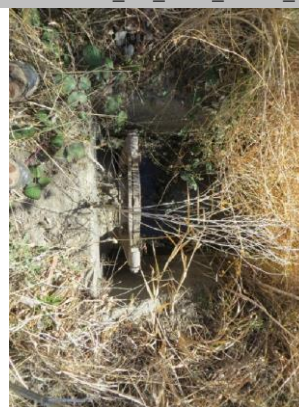
Photo 3 of 3 : UCIP\_SP\_2018\_51472\_49752.jpg

Flapgate at concrete headwall on WS toe.

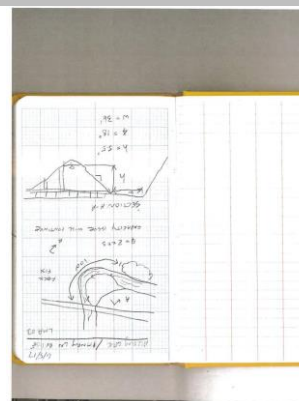
Photo 1 of 2 : LEVAL\_SP\_2018\_18\_1398.jpg

LM Start	0.99	Rating **	A/W	Issue No.	11
LM End	1.00	Issue Type +	Ma	Location *	
Category	Supplemental			GPS Latitude/Longitude	
				Start	End
Item	2017 Storm Damage			39.179715 °	39.179916 °
				-122.896926 °	-122.896970 °
DWR ID	DWR_NA0009_04_f_2017_11				
Comment Code					
Inspector Comment					
Levee Evaluation Comments					
Description:					
Site ID No:18					
Site Designation:LMA-3					
Repair Type: Erosion					
Rating:Critical					
Field Date:6/5/2017					
Notes: Erosion begins at the edge of the patrol road. Slope is covered in loose gravel, washes out every high water season.

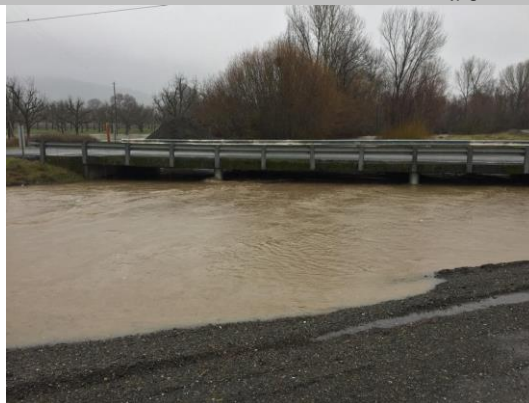
Photo 2 of 2 : LEVAL\_SP\_2018\_18\_335.jpg

LM Start	0.99	Rating **	A/W	Issue No.	11 (cont)	
LM End	1.00	Issue Type +	Ma	Location *		
Category	Supplemental			GPS Latitude/Longitude		
				Start	End	
Item	2017 Storm Damage			39.179715 °	39.179916 °	
				-122.896926 °	-122.896970 °	
DWR ID	DWR_NA0009_04_f_2017_11					
Comment Code						
Inspector Comment						
Levee Evaluation Comments						
Description:						
Site ID No:18						
Site Designation:LMA-3						
Repair Type: Erosion						
Rating:Critical						
Field Date:6/5/2017						
Notes: Erosion begins at the edge of the patrol road. Slope is covered in loose gravel, washes out every high water season.

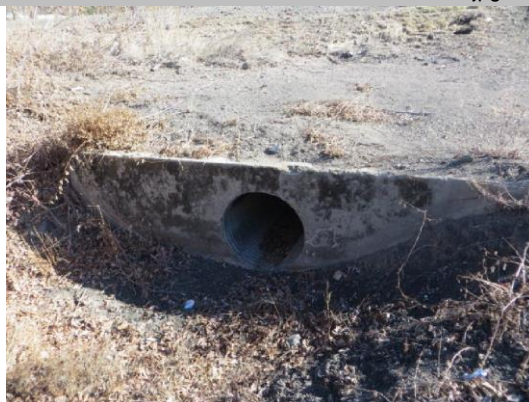
Photo 2 of 3 : UCIP\_SP\_2018\_26924\_49761.jpg

LM Start	1.19	Rating **	A/W	Issue No.	22
LM End	1.19	Issue Type +	Ma	Location *	
Category	Supplemental			GPS Latitude/Longitude	
				Start	End
Item	DWR UCIP LMA Responsibility			39.182079 °	39.182079 °
				-122.895038 °	-122.895038 °
DWR ID					
Comment Code					
Inspector Comment					
FS_ID:26924 DS_ID:21228 EP_NO: 11496 Repair Type: No Action Needed Crossing Status: Found UCIP Comments: FIELD_STRUCT_DESC: 42-inch corrugated metal drainage pipe through the levee, 8 feet below the crown. Flap gate on the waterside (WS) end. Concrete headwalls on both ends. (24-inch pipes [HLM 1.21] retained under Automatic Board Order (ABO) issued as Permit No. 11496, 1975 - Earl Foutch). [Additional Reference(s): DWR Levee Log, 2005. USACE Sacramento O&M Manual 506.2, August 1961, (HLM 1.21)]. FS Date: 1/9/2014

Concrete headwall and drainpipe visible at LS toe.

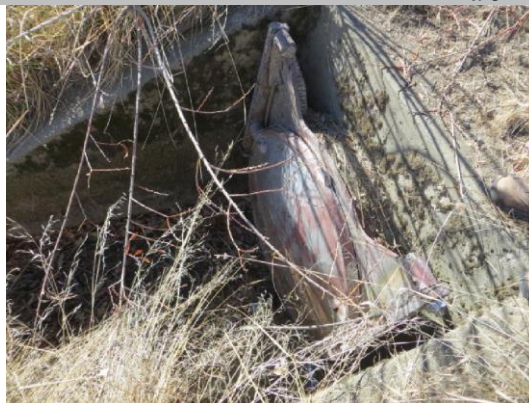
Photo 3 of 3 : UCIP\_SP\_2018\_26924\_49760.jpg

LM Start	1.19	Rating **	A/W	Issue No.	22 (cont)	
LM End	1.19	Issue Type +	Ma	Location *		
Category	Supplemental			GPS Latitude/Longitude		
				Start		End
Item	DWR UCIP LMA Responsibility			39.182079 °	39.182079 °	
				-122.895038 °	-122.895038 °	
DWR ID						
Comment Code						
Inspector Comment						
FS_ID:26924 DS_ID:21228 EP_NO: 11496 Repair Type: No Action Needed Crossing Status: Found UCIP Comments: FIELD_STRUCT_DESC: 42-inch corrugated metal drainage pipe through the levee, 8 feet below the crown. Flap gate on the waterside (WS) end. Concrete headwalls on both ends. (24-inch pipes [HLM 1.21] retained under Automatic Board Order (ABO) issued as Permit No. 11496, 1975 - Earl Foutch). [Additional Reference(s): DWR Levee Log, 2005. USACE Sacramento O&M Manual 506.2, August 1961, (HLM 1.21)]. FS Date: 1/9/2014

Concrete headwall visible off WS berm.

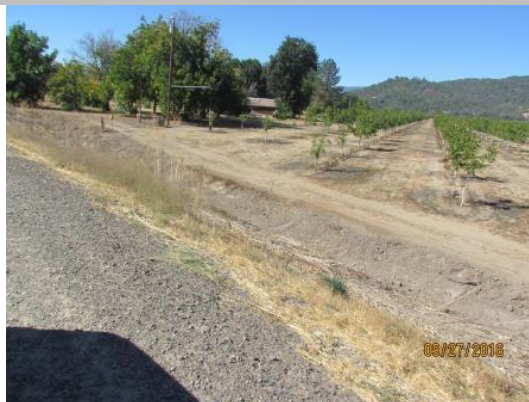
Photo 1 of 1 : SP\_2018\_NA0009\_6\_13\_20180305\_00006.jpg

LM Start	1.19	Rating **	M	Issue No.	13
LM End	1.25	Issue Type +	En	Location *	LS
Category	Earthen Levee			GPS Latitude/Longitude	
				Start	End
Item	Encroachments			39.182161 °	39.182862 °
				-122.894983 °	-122.894505 °
DWR ID	DWR_NA0009_04_f_2016_13				
Comment Code					
DT : Ditch					
Inspector Comment

View of a ditch at the landside toe looking downstream.

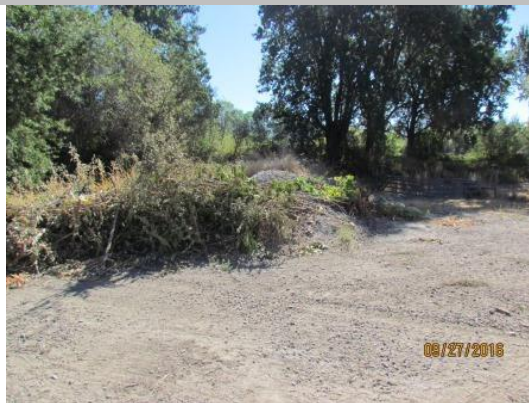
Photo 1 of 1 : SP\_2018\_NA0009\_6\_10\_20180305\_00002.jpg

LM Start	1.42	Rating **	M	Issue No.	10
LM End	1.42	Issue Type +	En	Location *	WS
Category	Earthen Levee			GPS Latitude/Longitude	
				Start	End
Item	Encroachments			39.185074 °	39.185074 °
				-122.893382 °	-122.893382 °
DWR ID	DWR_NA0009_04_f_2016_10				
Comment Code					
DE : Debris					
Inspector Comment

View of the prunings and soil pile on the waterside berm looking downstream.

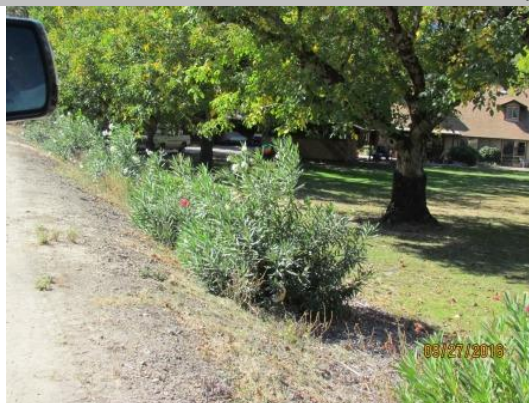
Photo 1 of 1 : SP\_2018\_NA0009\_6\_4\_20180305\_00001.jpg

LM Start	1.43	Rating **	M	Issue No.	4
LM End	1.46	Issue Type +	En	Location *	LS
Category	Earthen Levee			GPS Latitude/Longitude	
				Start	End
Item	Vegetation			39.185183 °	39.185568 °
				-122.893384 °	-122.893348 °
DWR ID	DWR_NA0009_04_f_2016_4				
Comment Code					
V6 : Landscaping					
Inspector Comment					
Oleanders blocking visibility.

View of the Oleanders looking downstream.

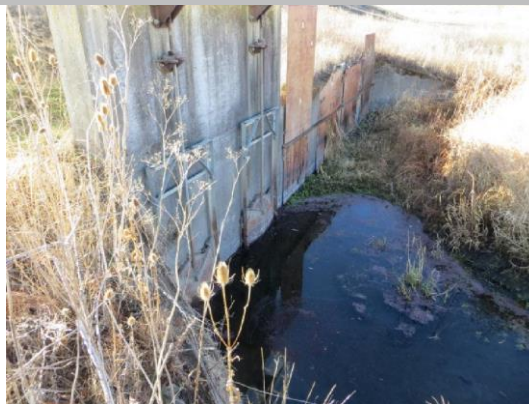
Photo 3 of 3 : UCIP\_SP\_2018\_26897\_49710.jpg

Comment Code						
Inspector Comment						
FS_ID:26897 DS_ID:21235 EP_NO: 11507 Repair Type: Non-Urgent Crossing Status: Found UCIP Comments: 10/27/2017 This structure is inspected annually under the Structure and Channel Summer Inspection (part of the Levee Inspection Program) conducted by the DWR Flood Project Integrity and Inspection Branch (FPIIB). (DWR UCIP - O. Magana) Some sediment buildup at LS toe. FIELD_STRUCT_DESC: [Clover Creek Diversion Structure] 1 of 6: 36-inch corrugated metal drainage pipe through the levee, 12 feet below the crown. Slide gate on the waterside (WS) end. Steel walkway on the WS slope to slide gate. Concrete headwall on both ends. (six 36-inch pipes and structure [HLM 0.3] retained under Automatic Board Order (ABO) issued as Permit No. 11507, 1975 - Lake County Flood Control and Water Conservation District). [Additional Reference(s): DWR Levee Log, 2005. USACE Sacramento O&M Manual 506, Part 2, August 1961, (HLM 0.31)]. FS Date: 1/9/2014

Slide gate at concrete headwall on WS toe.

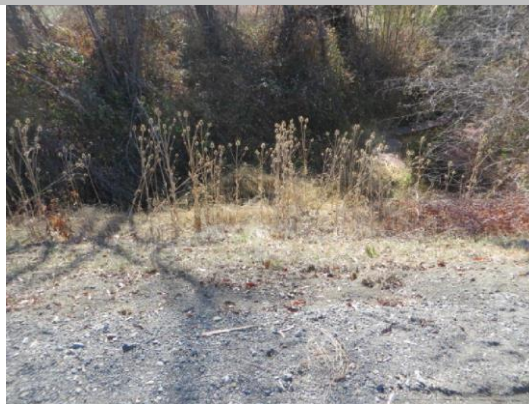
Photo 2 of 3 : UCIP\_SP\_2018\_26888\_49665.jpg

Comment Code					
Inspector Comment					
FS_ID:26888 DS_ID:21233 EP_NO: 11507 Repair Type: Non-Urgent Crossing Status: Found UCIP Comments: 10/27/2017 This structure is inspected annually under the Structure and Channel Summer Inspection (part of the Levee Inspection Program) conducted by the DWR Flood Project Integrity and Inspection Branch (FPIIB). (DWR UCIP - O. Magana) Some sediment buildup at outlet on LS toe. FIELD_STRUCT_DESC: [Clover Creek Diversion Structure] 3 of 6: 36-inch corrugated metal drainage pipe through the levee, 12 feet below the crown. Concrete headwall on both ends. Steel slide gate plate blocks inlet on the waterside (WS) toe. (six 36-inch pipes and structure [HLM 0.3] retained under Automatic Board Order (ABO) issued as Permit No. 11507, 1975 - Lake County Flood Control and Water Conservation District). [Additional Reference(s): DWR Levee Log, 2005. USACE Sacramento O&M Manual 506, Part 2, August 1961, (HLM 0.31)]. FS Date: 1/9/2014

Outlet visible at concrete headwall on LS toe.

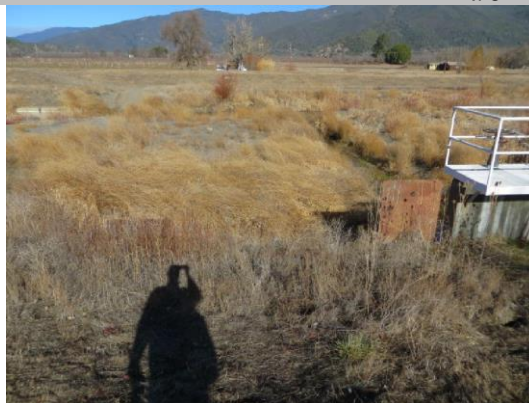
Photo 1 of 3 : UCIP\_SP\_2018\_26883\_49622.jpg

FS\_ID:26883  
DS\_ID:21231  
EP\_NO: 11507  
Repair Type: Non-Urgent  
Crossing Status: Found  
UCIP Comments: 10/27/2017 This structure is inspected annually under the Structure and Channel Summer Inspection (part of the Levee Inspection Program) conducted by the DWR Flood Project Integrity and Inspection Branch (FPIIB). (DWR UCIP - O. Magana)  
Some sediment buildup on LS toe.  
FIELD\_STRUCT\_DESC: [Clover Creek Diversion Structure] 5 of 6: 36-inch corrugated metal drainage pipe through the levee, 12 feet below the crown. Concrete headwall on both ends. Steel slide gate blocks inlet on the waterside (WS) toe. (six 36-inch pipes and structure [HLM 0.3] retained under Automatic Board Order (ABO) issued as Permit No. 11507, 1975 - Lake County Flood Control and Water Conservation District). [Additional Reference(s): DWR Levee Log, 2005. USACE Sacramento O&M Manual 506, Part 2, August 1961, (HLM 0.31)].

Metal slide gate visible at concrete headwall on WS toe.

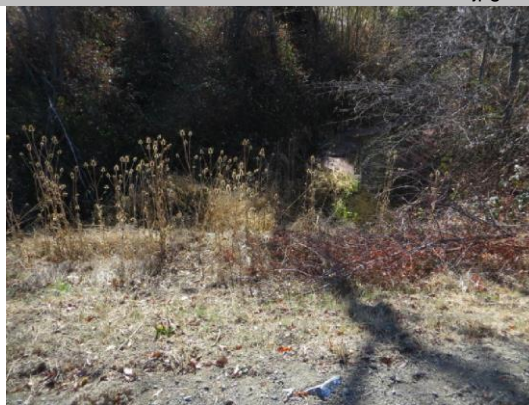
Photo 2 of 3 : UCIP\_SP\_2018\_26883\_49621.jpg

Pipe visible at concrete headwall on LS toe.

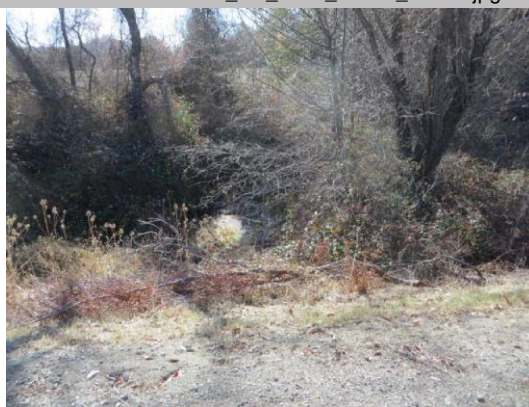
Photo 2 of 3 : UCIP\_SP\_2018\_26877\_49609.jpg

Comment Code						
Inspector Comment						
FS_ID:26877 DS_ID:21229 EP_NO: 11507 Repair Type: Non-Urgent Crossing Status: Found UCIP Comments: 10/27/2017 This structure is inspected annually under the Structure and Channel Summer Inspection (part of the Levee Inspection Program) conducted by the DWR Flood Project Integrity and Inspection Branch (FPIIB). (DWR UCIP - O. Magana) Some sediment buildup at outlet on LS toe. FIELD_STRUCT_DESC: [Clover Creek Diversion Structure] 6 of 6: 36-inch corrugated metal drainage pipe through the levee, 12 feet below the crown. Concrete headwall on both ends. Steel slide gate covers waterside (WS) inlet. (six 36-inch pipes and structure [HLM 0.3] retained under Automatic Board Order (ABO) issued as Permit No. 11507, 1975 - Lake County Flood Control and Water Conservation District). [Additional Reference(s): DWR Levee Log, 2005. USACE Sacramento O&M Manual 506, Part 2, August 1961, (HLM 0.31)]. FS Date: 1/9/2014

Concrete headwall on LS toe.

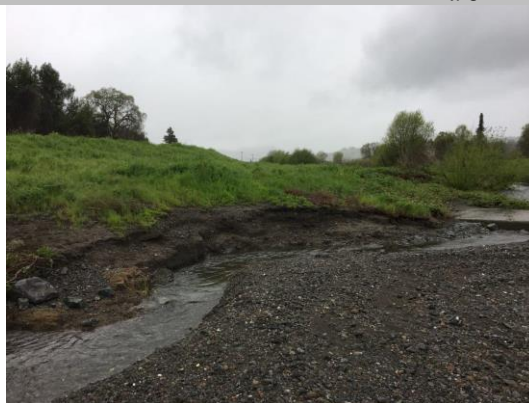
Photo 2 of 3 : LEVAL\_SP\_2018\_19\_354.jpg

LM Start	0.32	Rating **	A/W	Issue No.	13 (cont)	
LM End	0.32	Issue Type +	Ma	Location *		
Category	Supplemental			GPS Latitude/Longitude		
				Start	End	
Item	2017 Storm Damage			39.177150 °	39.177150 °	
				-122.899111 °	-122.899111 °	
DWR ID	DWR_NA0009_05_f_2017_13					
Comment Code						
Inspector Comment						
Levee Evaluation Comments						
Description:						
Site ID No:19						
Site Designation:LCWPD-01						
Repair Type: Erosion						
Rating:Area of Concern						
Field Date:6/5/2017						
Notes: Erosion exists between a small weir and diversion pipes.

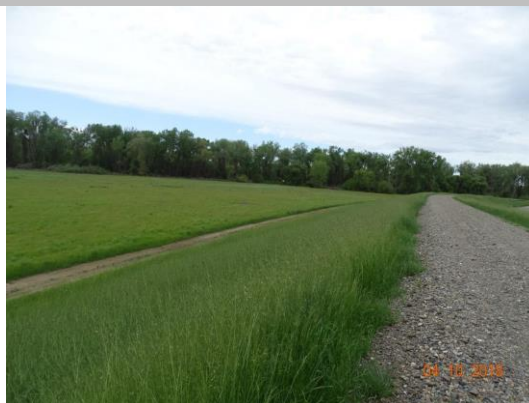
Photo 1 of 1 : SP\_2018\_NA0009\_7\_12\_20180416\_00028.jpg

LM Start	0.71	Rating **	M	Issue No.	12
LM End	0.71	Issue Type +	Ma	Location *	LS
Category	Earthen Levee			GPS Latitude/Longitude	
				Start	End
Item	Vegetation			39.175755 °	39.175755 °
				-122.905820 °	-122.905820 °
DWR ID	DWR_NA0009_05_s _ 2018_12				
Comment Code					
V1 : Control annual grass and weeds on the levee slopes and easements.					
Inspector Comment					
Native grass should be maintained.

View of native vegetation on landside slopes.

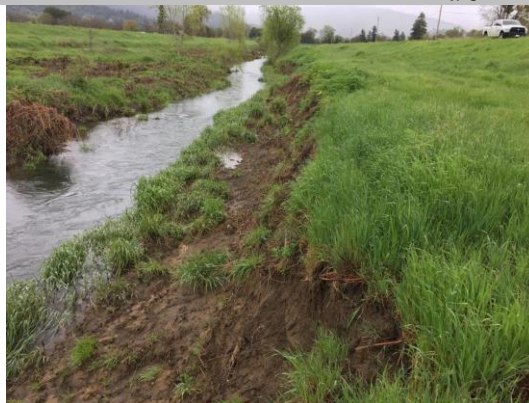
Photo 3 of 3 : LEVAL\_SP\_2018\_20\_350.jpg

LM Start	0.82	Rating **	A/W	Issue No.	20 (cont)	
LM End	0.86	Issue Type +	Ma	Location *		
Category	Supplemental			GPS Latitude/Longitude		
				Start		End
Item	2017 Storm Damage			39.175740 °		39.175750 °
				-122.907980 °		-122.908710 °
DWR ID	DWR_NA0009_05_f_2017_20					
Comment Code						
Inspector Comment						
Levee Evaluation Comments						
Description:						
Site ID No:20						
Site Designation:LCWPD-02						
Repair Type: Erosion						
Rating:Area of Concern						
Field Date:6/5/2017						
Notes: 5 - 7 ft deep erosion scarps, bank is normally near vertical but at a much smaller drop off, 1 - 3 ft.
